Arboricultural Impact Assessment Report & Tree Protection Plan and Specification

APT Woolloomooloo
Facility installation

March 2022
FINAL

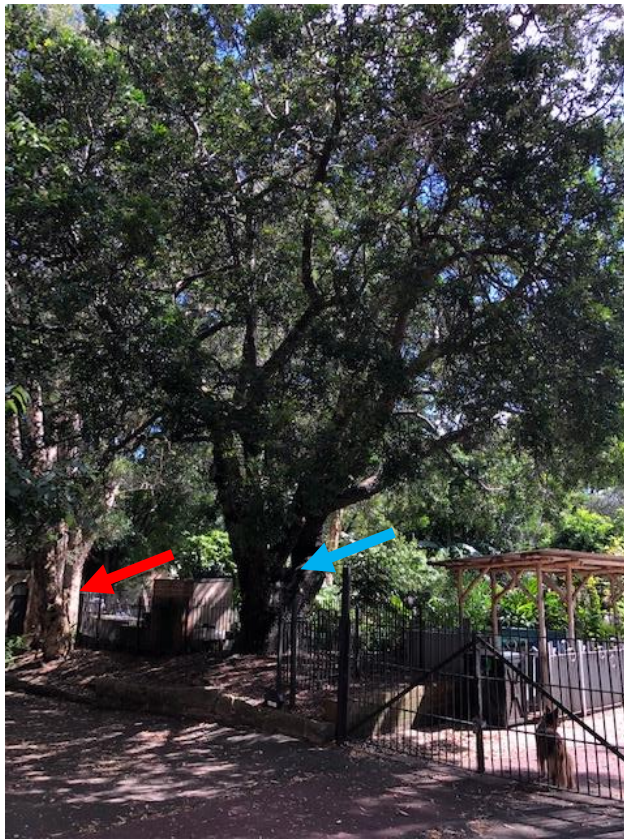
- 3.4** Trees 1 and 2 are likely to have been planted either before, or at the same time as, the adjacent sandstone garden edge was constructed (Plate 1). This may have had an impact on the direction of the root system of these trees and as such the trees may have a slightly reduced woody rootzone due to deflecting off these large stone blocks. Both trees have had extensive crown reduction pruning with the removal of lower first order limbs back to the main trunks.

Plate 1: Tree 1 (red arrow), Tree 2 (Blue arrow). P.Vezgoff

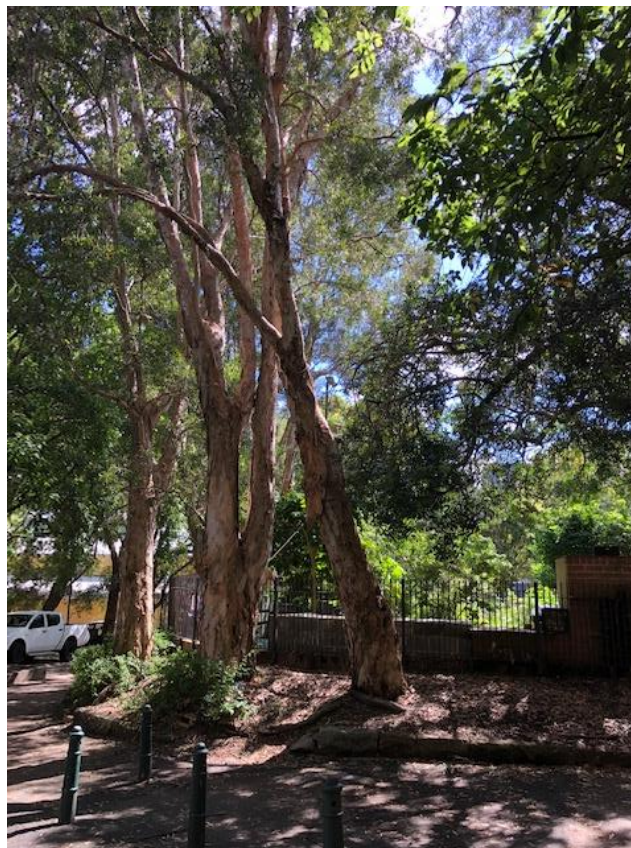
Plate 2: Tree 1 on slight lean to the south. P.Vezgoff

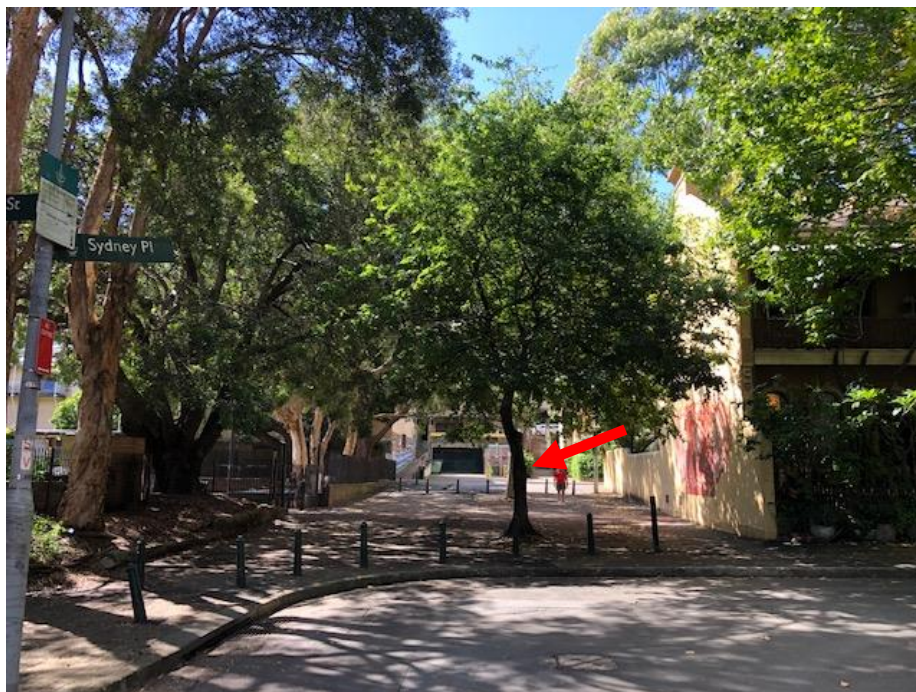
3.5 Tree 3 is in good health and condition (Plate 3) however recent trenching has certainly breached the TPZ and SRZ on this tree (Plate 4). This tree has developed a fine network of branches creating a rounded canopy. Canopy overhang with Tree 3 in conflict with the installation of the APT will need to be considered.

Plate 3: Image showing Tree 3 (Red arrow). P.Vezgoff

- 4.5** Another potential impact to Tree 3 is to the canopy and its proximity to craning vehicles but also the final position of the APT. The choice of vehicle shall be confirmed prior to works commencing and shall ensure that the boom and slings will remain clear of all tree canopies. If this does not occur it is possible branches could tear from the subject trees, thus causing extensive detrimental damage that Council may request any bond on any tree be surrendered. The final location of the APT may also require reduction pruning of approximately 10-15% of the canopy of Tree 3.

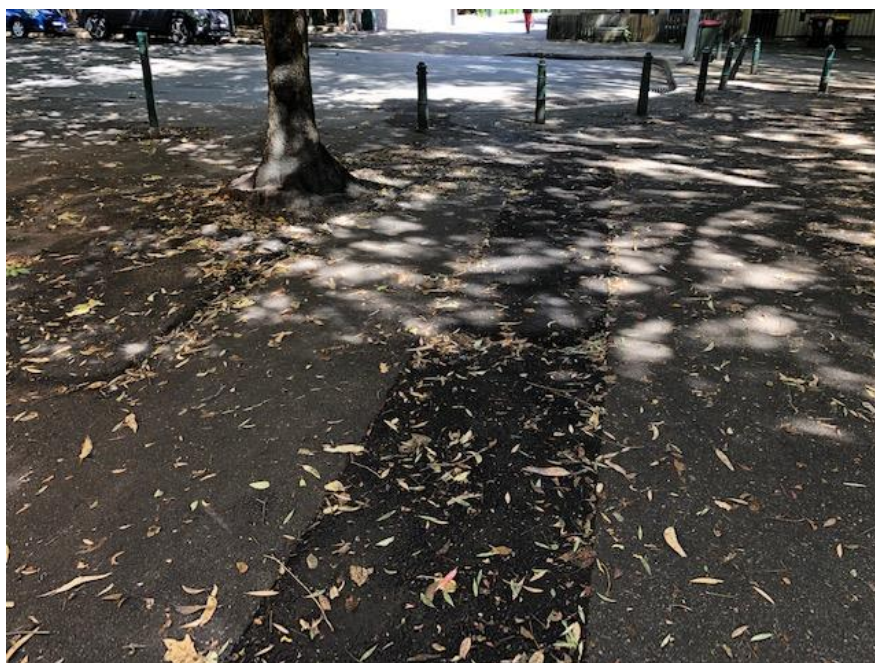
Plate 4: Image showing new trenching below Tree 3. P.Vezgoff

- 4.6** Council has specified (letter dated 22nd November 2021, Author Michael Soo) that non-destructive exploratory excavations are to occur to expose roots greater than forty (40) millimetres in diameter. This is an option for this site due to it being clear of any structures.
- 4.7** In conclusion, another site may be a better option for this APT however further assessment of the service trenching locations in relation to TPZ areas of the three (3) trees and also the impacts to the canopy of Tree 3 may not be accepted by Council. If no other options are available a *Tree Pruning Specification Report (TPSR)* will be required so that excessive pruning is not undertaken on this tree. This TPSR will be required by Council.

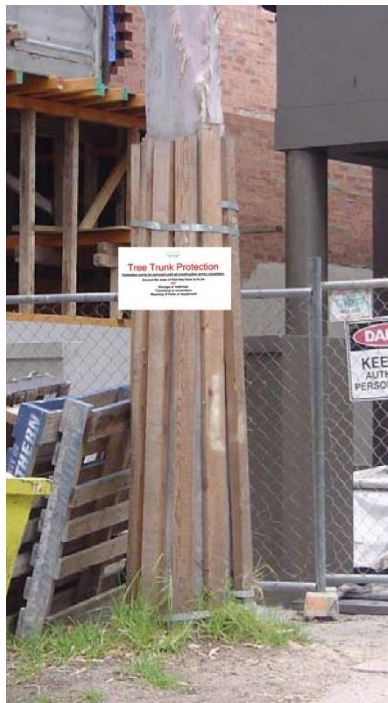
4.1 Individual trunk protection: Trees 1, 2 and 3 will require trunk protection. This is achieved by attaching lengths of timber (75mm x 50mm x 2000mm) fastened around the trunk. Geotextile fabric or carpet underlay shall be wrapped around the trunk prior to the timbers being attached. These timbers are to be fastened with hoop iron strapping and not attached directly into the bark of the tree. These timbers are only to be removed when all construction is complete. See Plate A for an example of trunk protection.

Plate A: Example of trunk protection. P. Vezgoff.

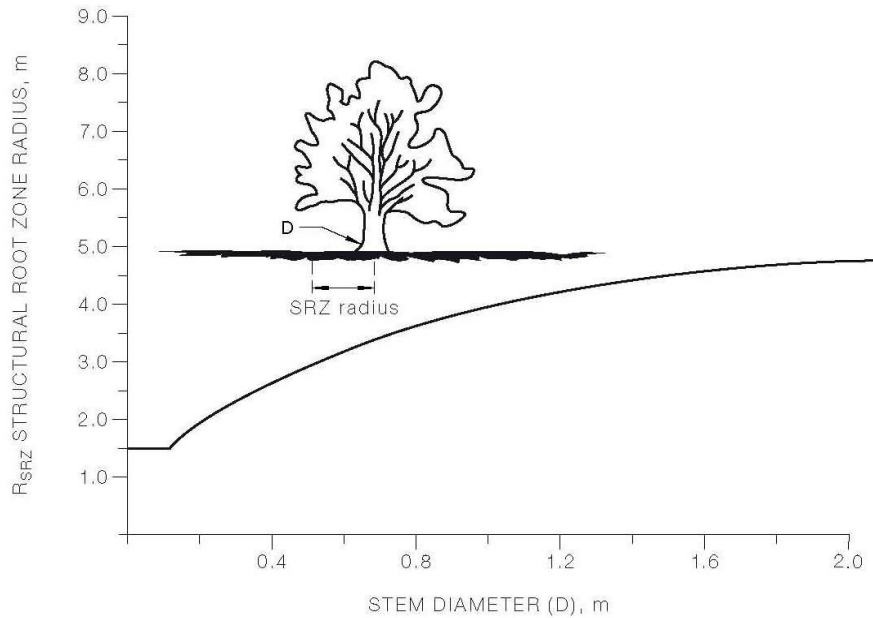
FIGURE 1 - STRUCTURAL ROOT ZONE

NOTE: The SRZ for trees with trunk diameters less than 0.15m will be 1.5m (see Figure 1).

The curve can be expressed by the following formula:
 $R_{SRZ} = (D \times 50)^{0.42} \times 0.64$
