HISTORY HOUSE

113 Macquarie Street
Sydney, NSW

Conservation Management Plan

Revision of 2001 CMP

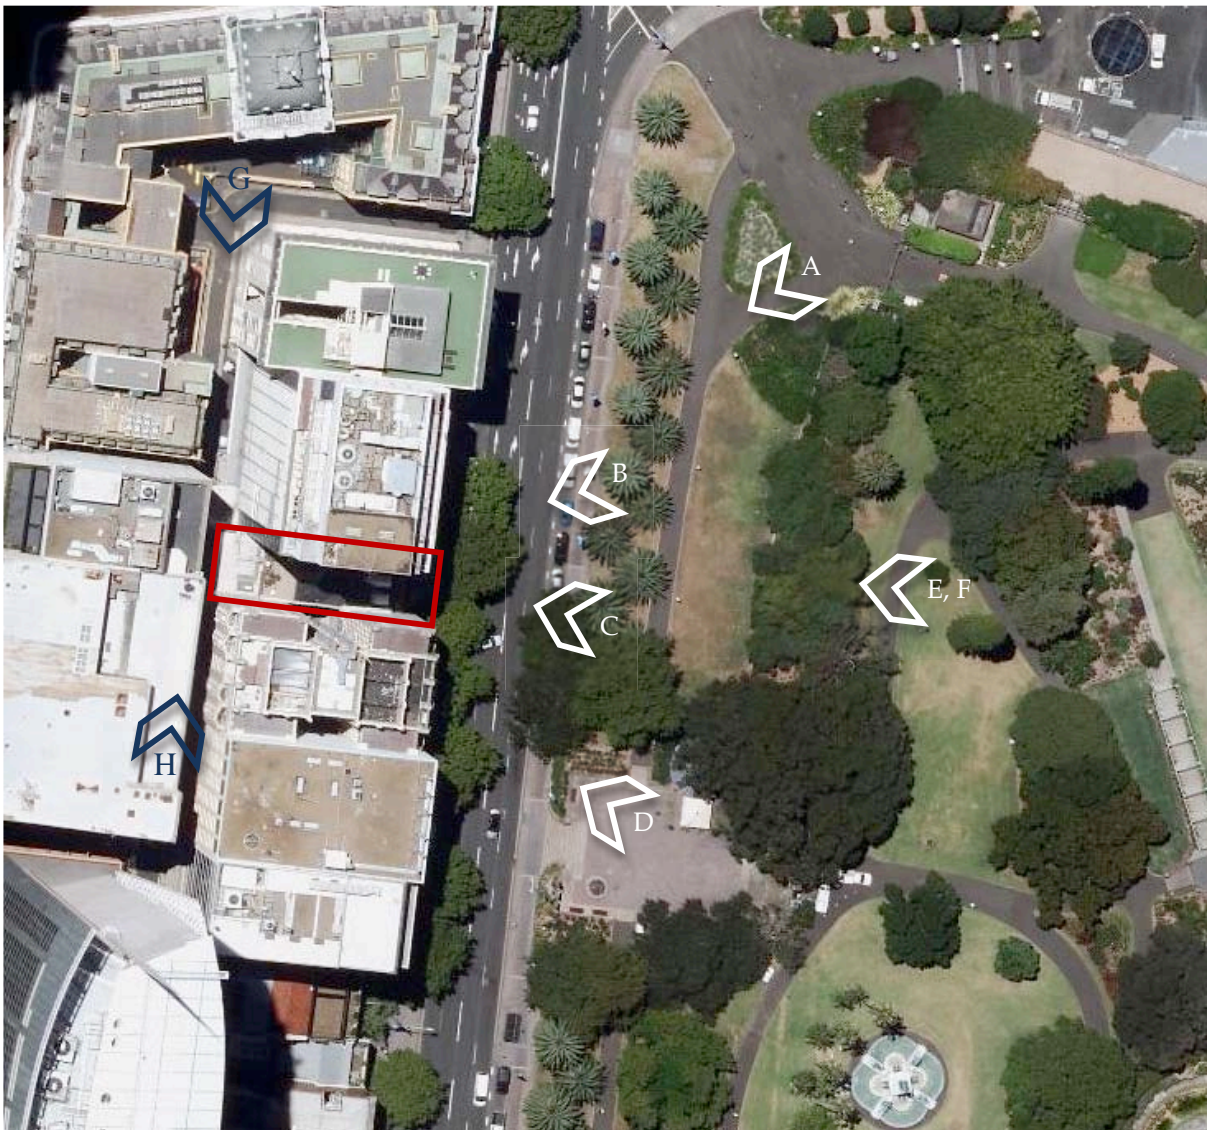
FIGURE 2.8: Approximate location of view study photographs. History house is outlined in red.
(Source: Six Maps, 2016)

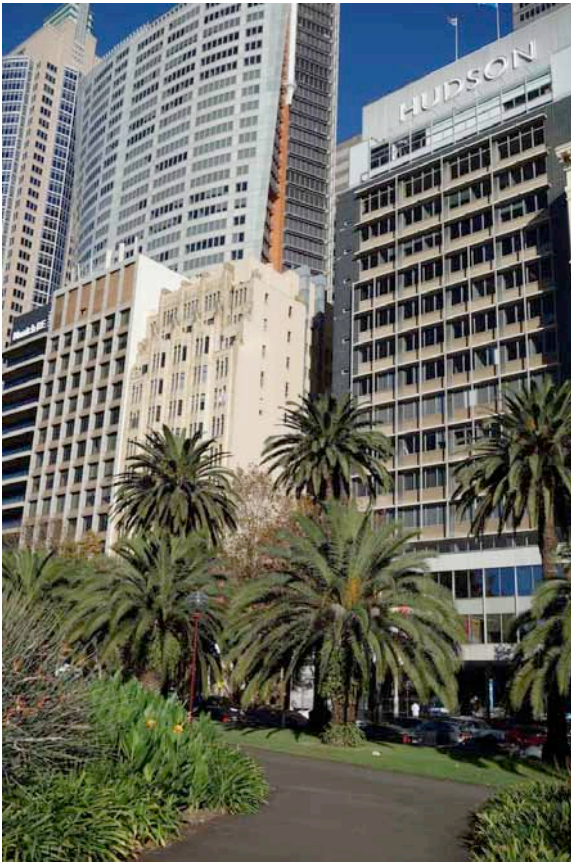
FIGURE 2.9: View A: filtered views looking south west from the Botanical Gardens

Views of No. 133 are available from the western edge of the Botanical Gardens, however these are similarly filtered through the mature plantings along the western edge of the gardens. Views of the attic level of No. 133 are available above these plantings from a crest of land within the gardens directly opposite. Again the stark contrast in height between No. 133, BMA House, Hudson House and development further to the west (chiefly Governor Macquarie tower) and the negative space above No. 133 is most apparent in this view.

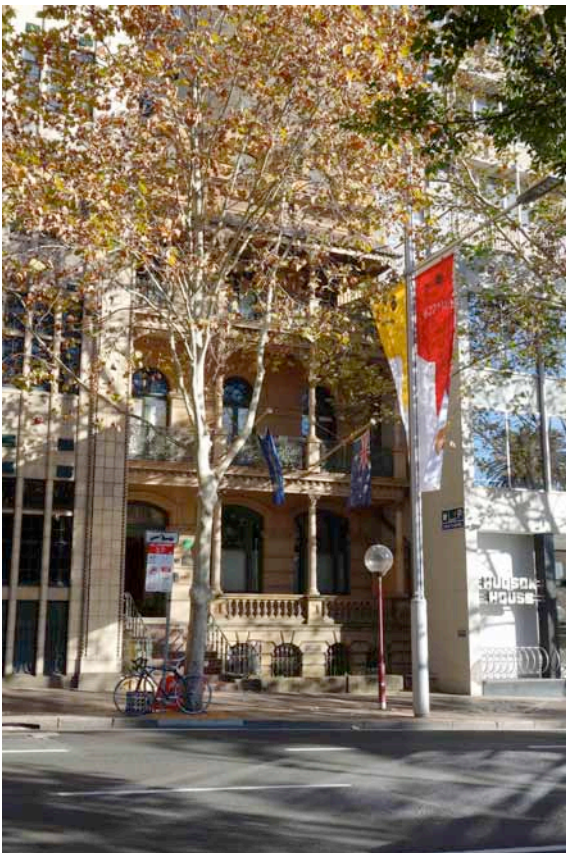
FIGURE 2.11: View C: filtered views looking north west from Macquarie Street.

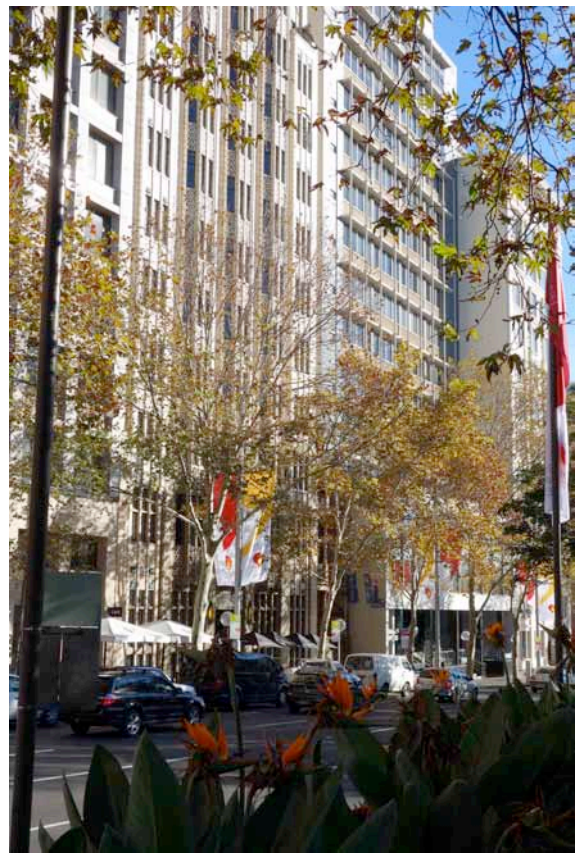
FIGURE 2.12: View D: oblique views are largely obscured by the adjacent BMA House which is located on the street alignment.

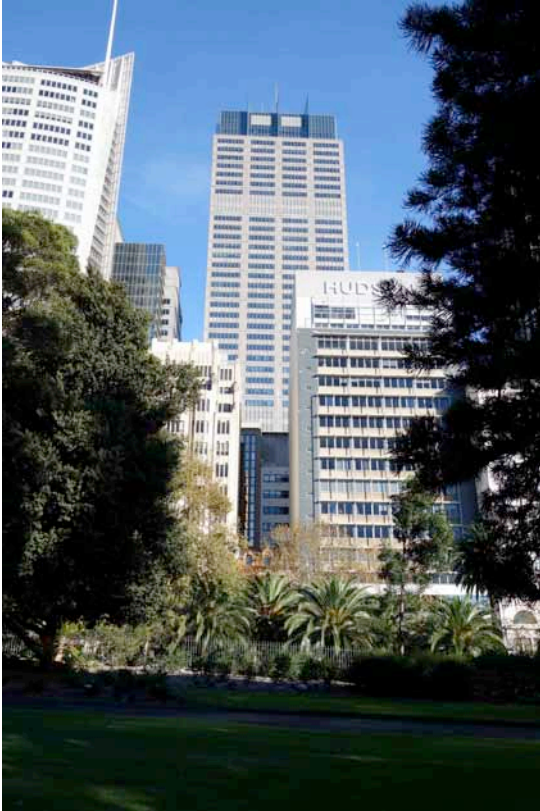
FIGURE 2.13: View E: the attic and roof levels are visible in direct views looking west from a crest on the western side of the Botanical Gardens

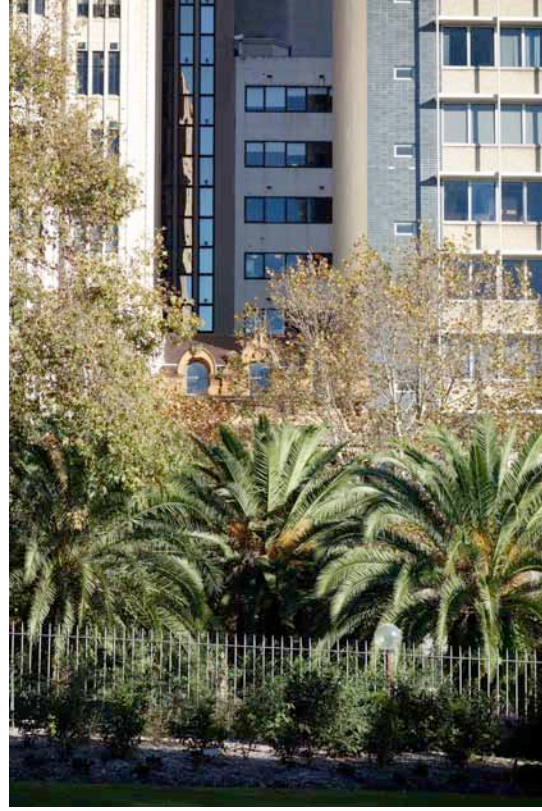
FIGURE 2.14: View F: Close up view looking directly west from the crest on the western side of Botanical Gardens.

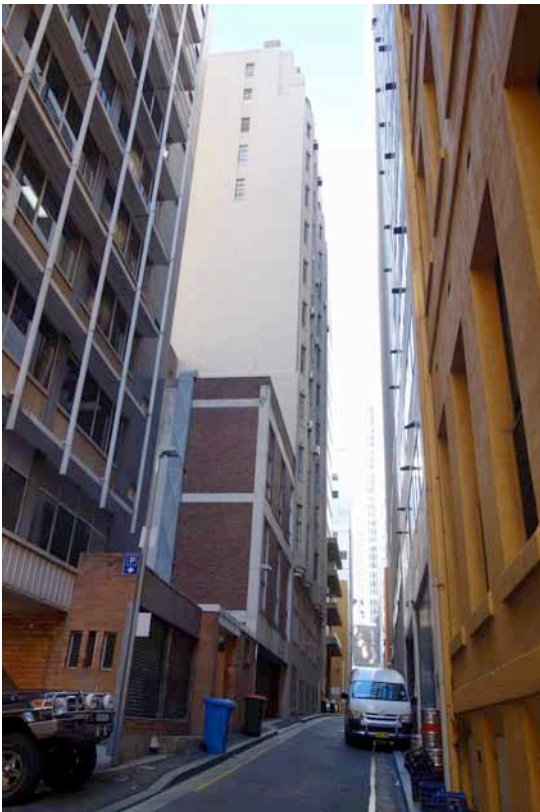
FIGURE 2.15: View G: Looking south along Phillip Lane.

From Phillip Lane at the rear there is no view of the historical portion of No. 133 Macquarie Street. This view is dominated by the 1970 construction at the rear. Modern buildings are constructed right up to the building alignment and form the dominant character of the laneway.

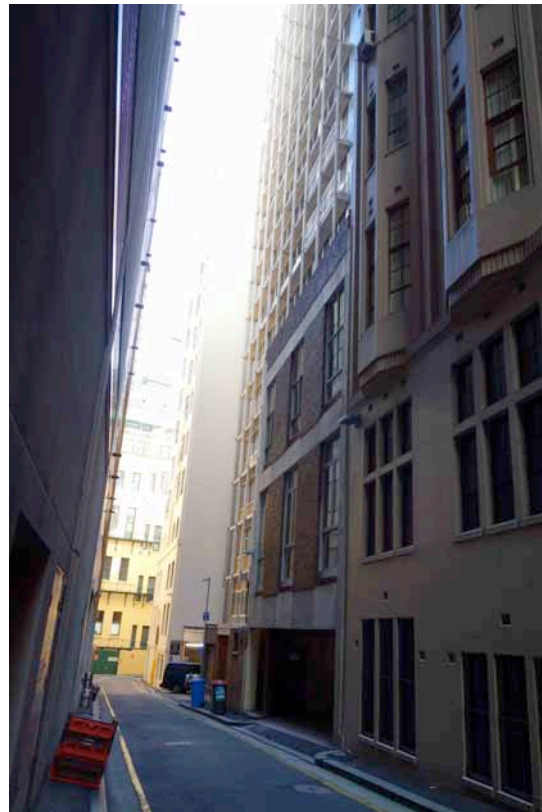
FIGURE 2.16: View H: Looking north along Phillip Lane. This view is terminated by the historic Chief Secretary's Building.
